FULL RESERVE STUDY

***RIVERWATCH
GLOUCESTER, VA***

Prepared for:
***RIVERWATCH HOMEOWNERS ASSOCIATION
GLOUCESTER, VA
&
COMMUNITY PARTNERS OF VA, INC.***

AUGUST 15, 2016

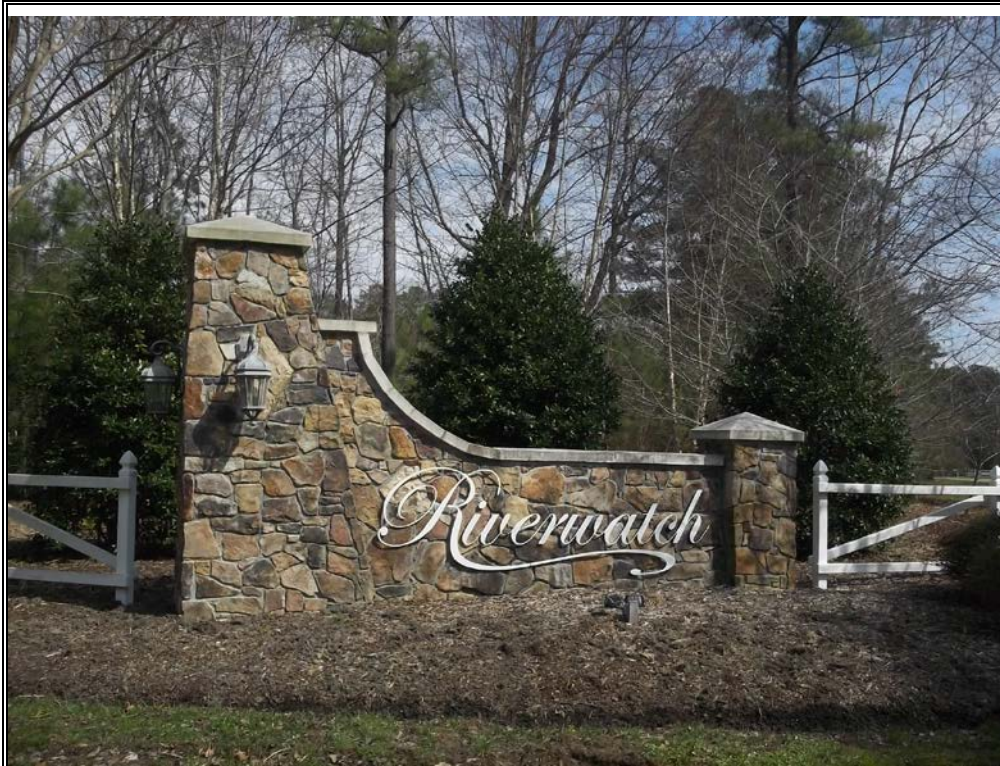
Photo Number
1

Description:
Monument
entrance sign.

Entrance signs in the community are comprised of a small recently installed monument sign at the Riverwatch Drive entrance and two larger stone veneer monument signs with metal lettering at the East West Parkway entrance. We have assumed minor repairs to the lettering would be funded from an annual maintenance budget. We have allocated funds for more significant repairs to the monument structures including stone veneer repairs and repointing on a 15 year cycle beginning in 2024.

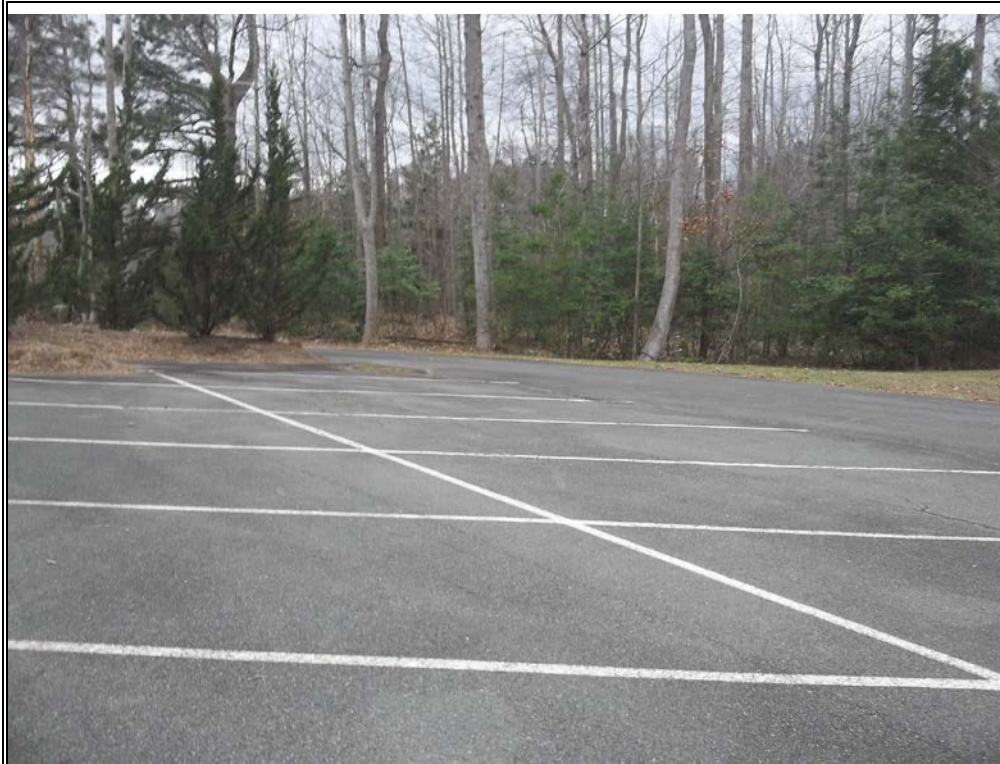
Photo Number
2

The association is responsible for maintaining the asphalt paved parking lot at the swimming pool. The paved surface generally appeared to be in good to fair condition. Longitudinal cracking was observed in sections of the asphalt paving. The parking lot lines are faded in color and it does not appear that the paving has been seal coated since original construction.

Description:
Asphalt paved
parking lot at
swimming pool
area.

Typically, we recommend the application of an oil resistant sealant to all asphalt paved surfaces on an approximately 7 year cycle. At this same time, all cracks should be properly filled, patched, and sealed. We have allocated funds to seal the pavement on a 7 year cycle beginning in 2017.

Assuming sealing and crack repairs occur in the interim, we anticipate the asphalt paving in the community to have an estimated useful life of approximately twenty to twenty-five years prior to full resurfacing. We have allocated funds to resurface the asphalt paving in 2029. Resurfacing would include repairing any potholes or depressions and installing a new wearing layer of asphalt (1" to 2" thick) over the existing paving.

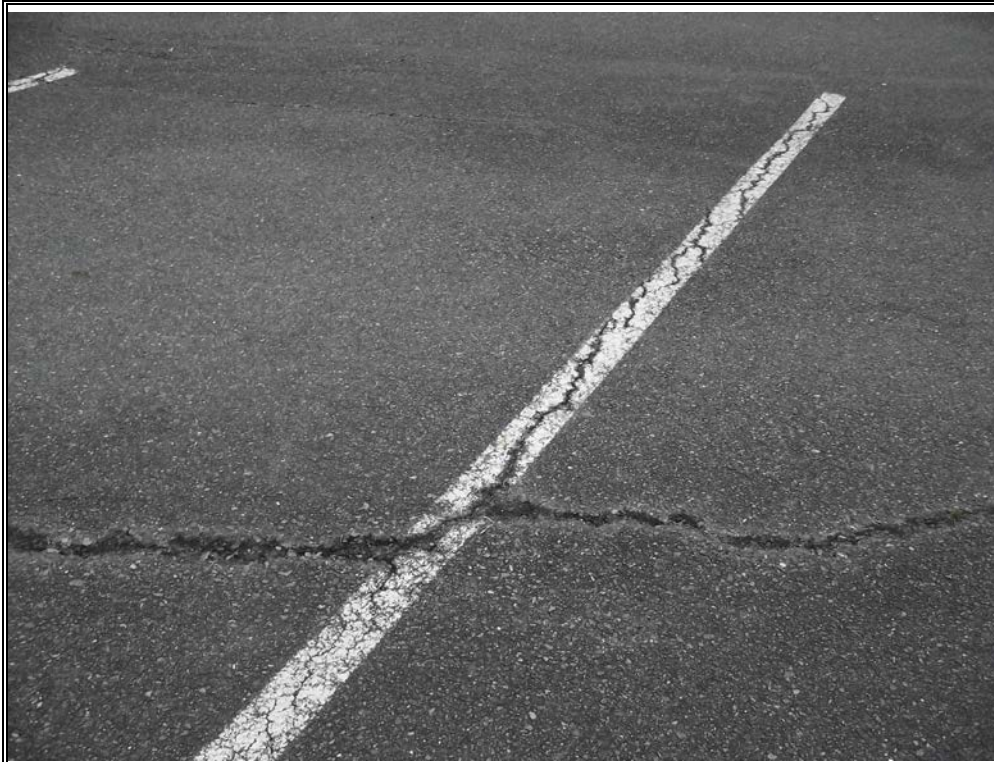
Photo Number
3

Description:
Longitudinal
cracking
developing in
asphalt paving.

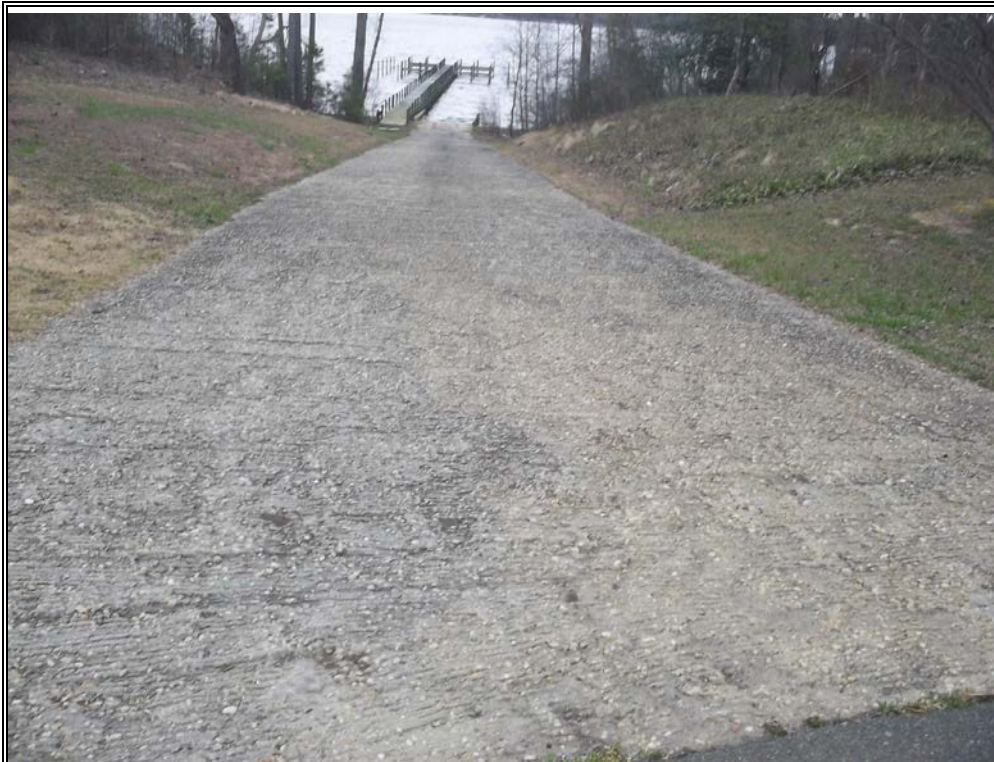
Photo Number
4

The association is responsible for maintaining the concrete pool deck, the concrete flatwork around the pool building and the concrete boat ramp. The concrete flatwork generally appears to be in good condition, with some minor cracking evident. We have allocated funds for periodic repairs and/or replacement of concrete surfaces as required and have assumed that 5% of the surfaces will require maintenance every 8 years beginning in 2025. Note that accumulated sand and sediment was observed at the shoreline at the boat ramp, we have assumed that periodic removal of the sediment would be funded from an annual maintenance budget. The concrete floor in the pool building is comprised of stamped

Description:
Concrete flatwork
at boat ramp.

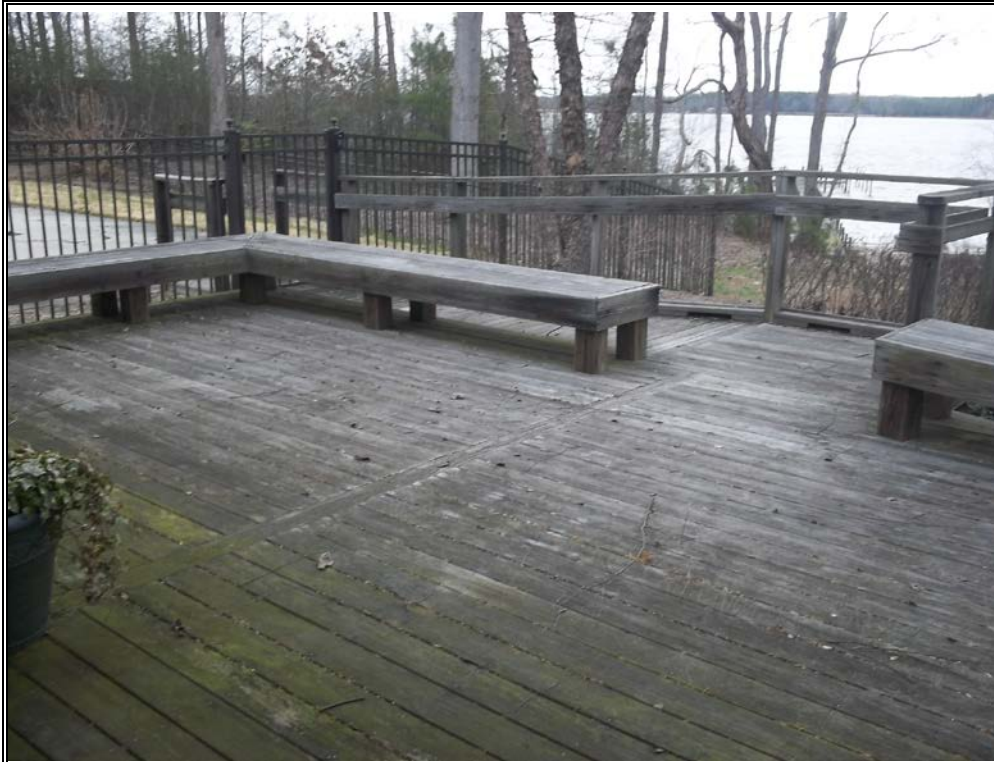
Photo Number
5

Wood decking is installed adjacent to the pool building and appeared to be in good to fair condition with some typical weathering observed. Wood decking has an expected useful life of approximately 15 years, we have allocated funds to replace the decking and rails adjacent to the pool building beginning in 2022.

Description:
Wood decking at
pool building.

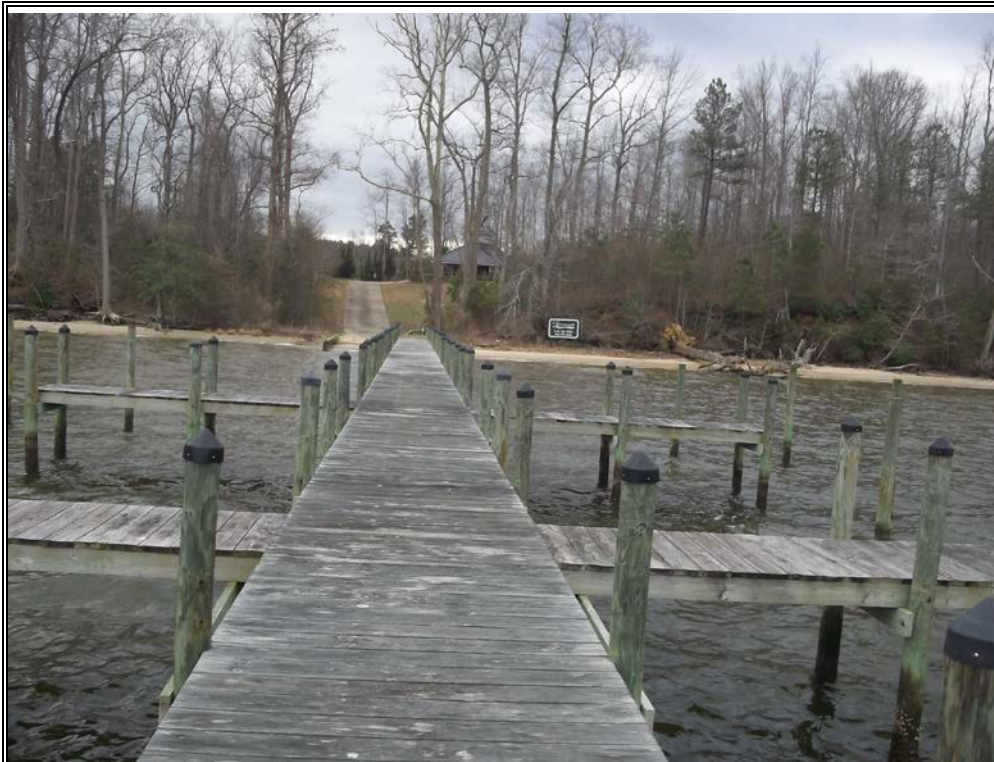
Photo Number
6

A wood framed boat dock is installed adjacent to the boat ramp near the amenity center in the community. The wood decking appeared to be in fair condition with some weathering evident. We have assumed minor repairs to the decking and railings would be funded from an annual maintenance budget. Assuming minor repairs are completed in the interim, we anticipate the boat dock to have an expected remaining useful life of approximately 15 years. It is likely that the wood pylons and wood framing of the framing at the boat dock will require significant structural repairs and/or full replacement in addition to full replacement of decking and rails. We have allocated funds for full replacement of the boat dock on a 30 year cycle beginning in 2032.

Description:
Wood boat dock.

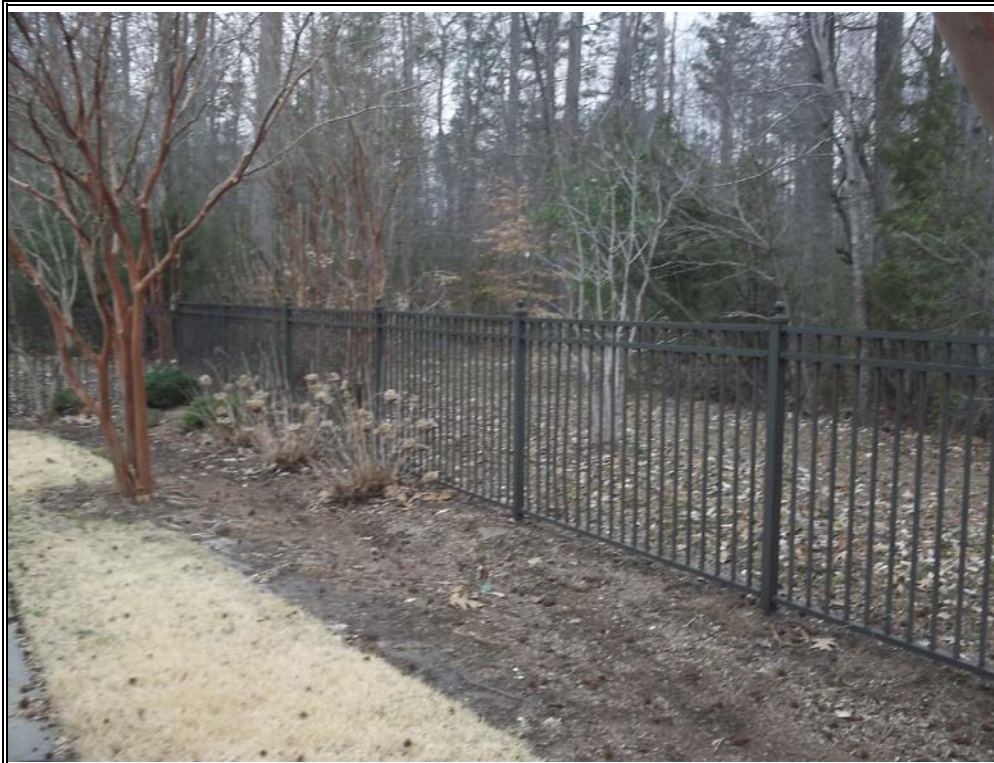
Photo Number
7

Anodized aluminum fencing is installed around the pool area in the community. The fencing generally appeared to be in good condition. The fencing has as an expected useful life beyond the term of this study. However, it is likely that minor repairs and full repainting of the fencing will be required on an approximately 15 year cycle. We have allocated funds to paint and repair the aluminum fencing beginning in 2025.

Description:
Aluminum fencing
at pool area.

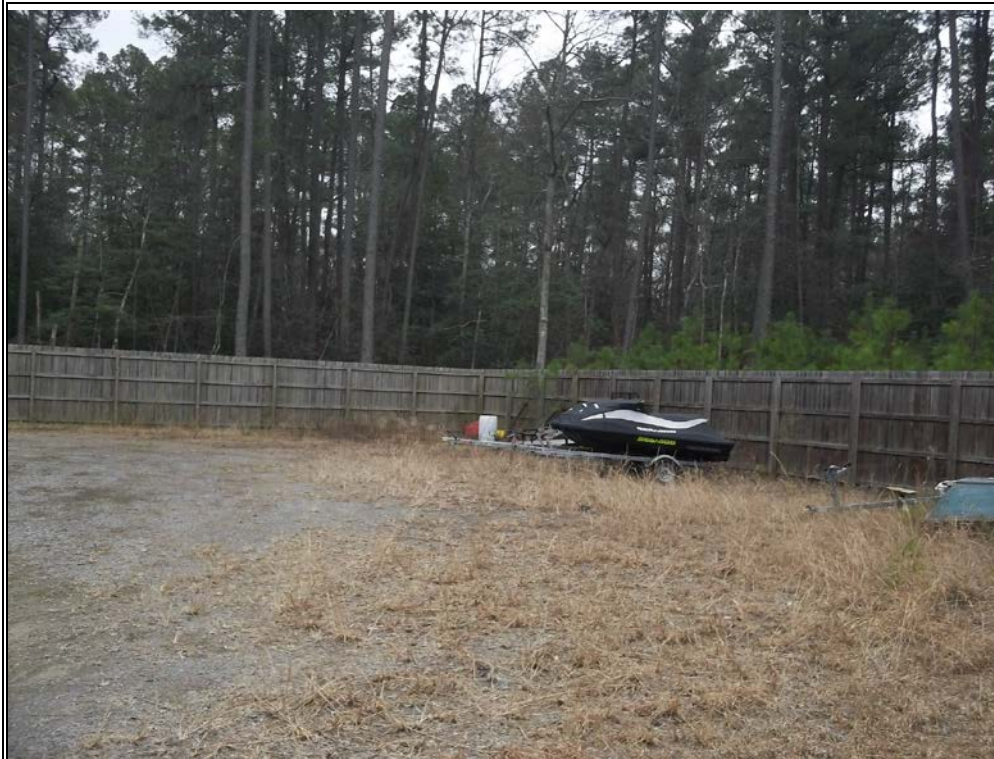
Photo Number
8

A gravel surfaced boat storage lot with gravel surfaced access drive is located off of Riverwatch Drive and maintained by the association. The boat storage area includes 8' tall wood perimeter fencing. The gravel surface appeared to be in fair condition with vegetative growth in areas. We have allocated funds to install additional gravel surfacing over the boat storage area and entrance drive on a 20 year cycle beginning in 2024. The wood fencing around the boat storage area is in fair condition with minor warping and damaged slats observed. We also observed vegetation in contact with the wood fencing around the perimeter. We recommend routinely trimming vegetation away from the wood fencing and have assumed this and minor repairs to the fencing would be funded from an annual maintenance budget. We have allocated funds to replace the wood fencing on a 20 year cycle beginning in 2029.

Description:
Boat storage lot
with gravel surface
and wood
perimeter fencing.

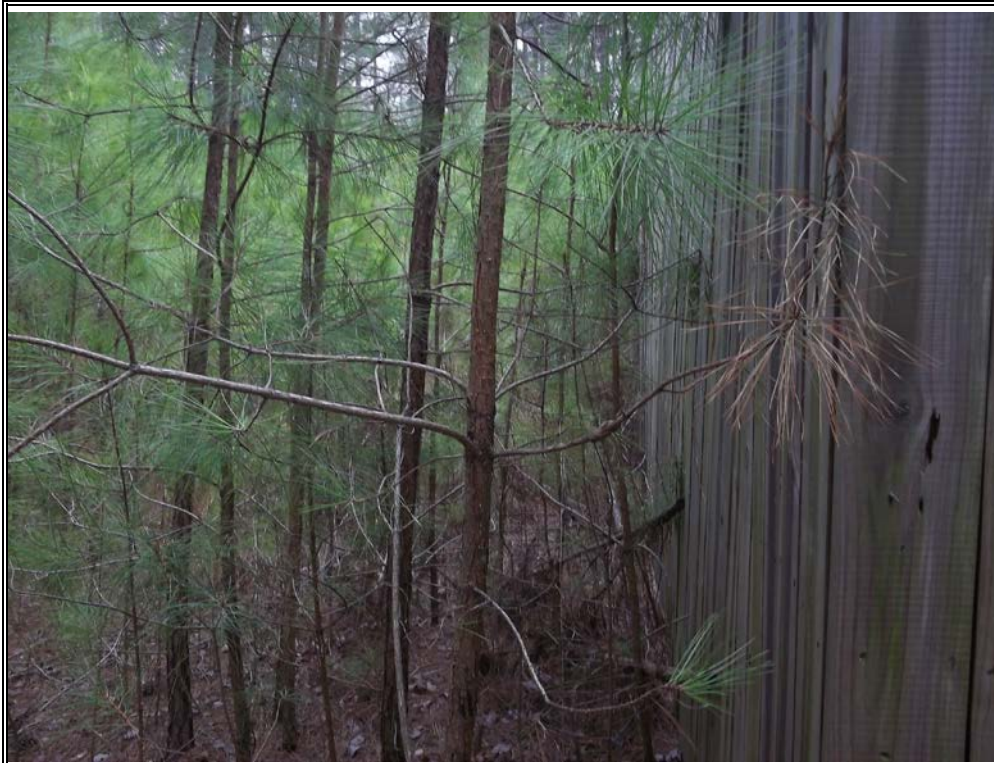
Photo Number
9

Description:
Vegetation in
contact with wood
perimeter fencing.

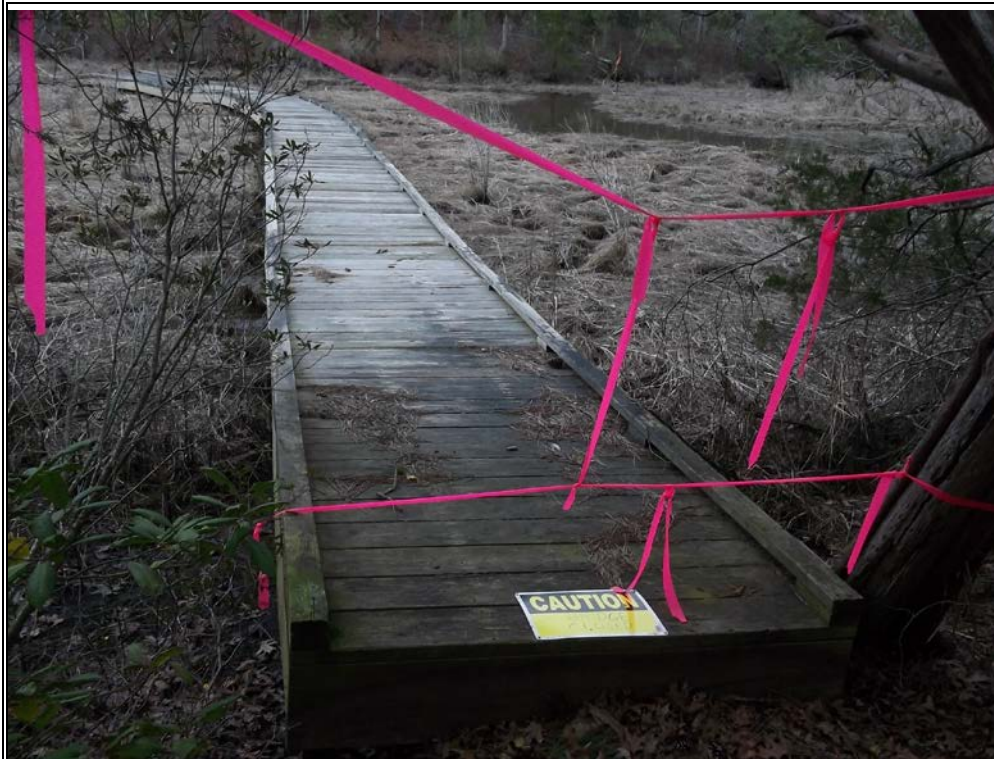
Photo Number
10

A walking trail is located in the community along a creek behind several lots in the community. The walking trail does not include any surfacing material (mulch, gravel, etc.). Eight wood framed pedestrian bridges were observed along the walking trail. The wood bridges range in size from small sections approximately 8 feet in length to longer sections spanning over 200 feet. The bridges varied in condition. The wood bridge near the trail head at the end of East West Parkway is in poor condition and is blocked from access. The wood bridge behind lots 2 and 3 on Rivers Edge

Description:
Wood framed
pedestrian bridge
on walking trail
blocked from
access, in poor
condition.

Terrace was also observed to be in poor condition and should be temporarily blocked from access until repairs are completed. The wood bridge behind lot 9 on Coveside Point is also in poor condition and will require repair in the near term. We have allocated funds to replace these wooden bridges on a 15 year cycle beginning in 2017 based on cost information provided. The remaining bridges appeared to be in fair condition. We have allocated funds to replace the remaining bridges on a 15 year cycle beginning in 2020.

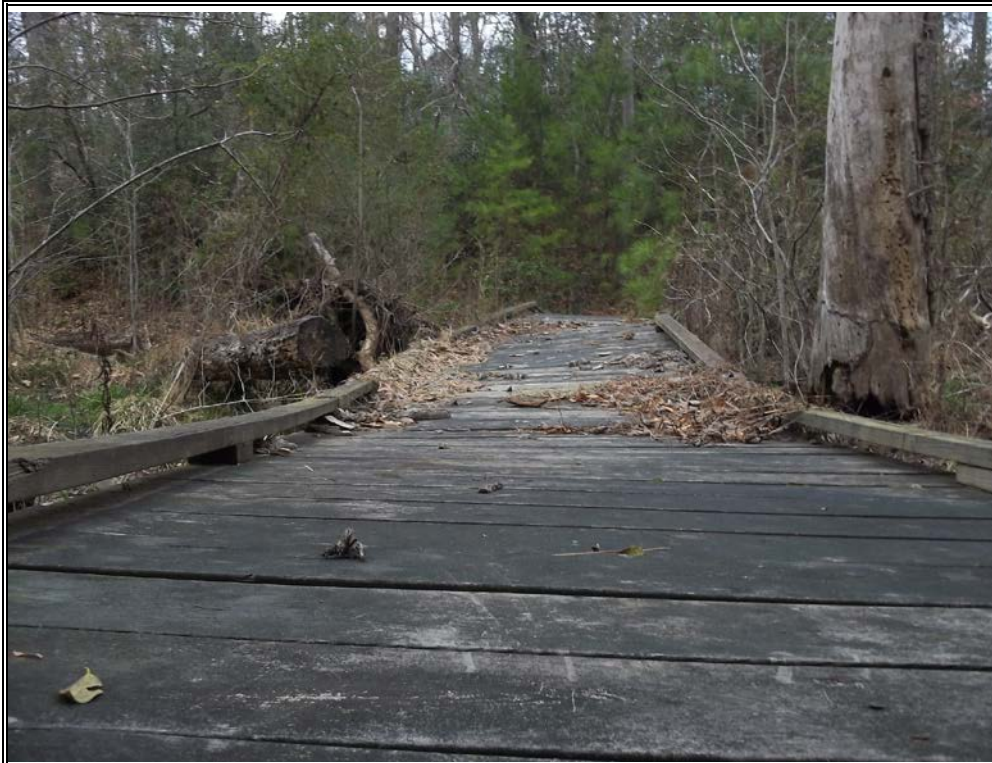
Photo Number
11

Description:
Additional wood
framed pedestrian
bridge in poor
condition.

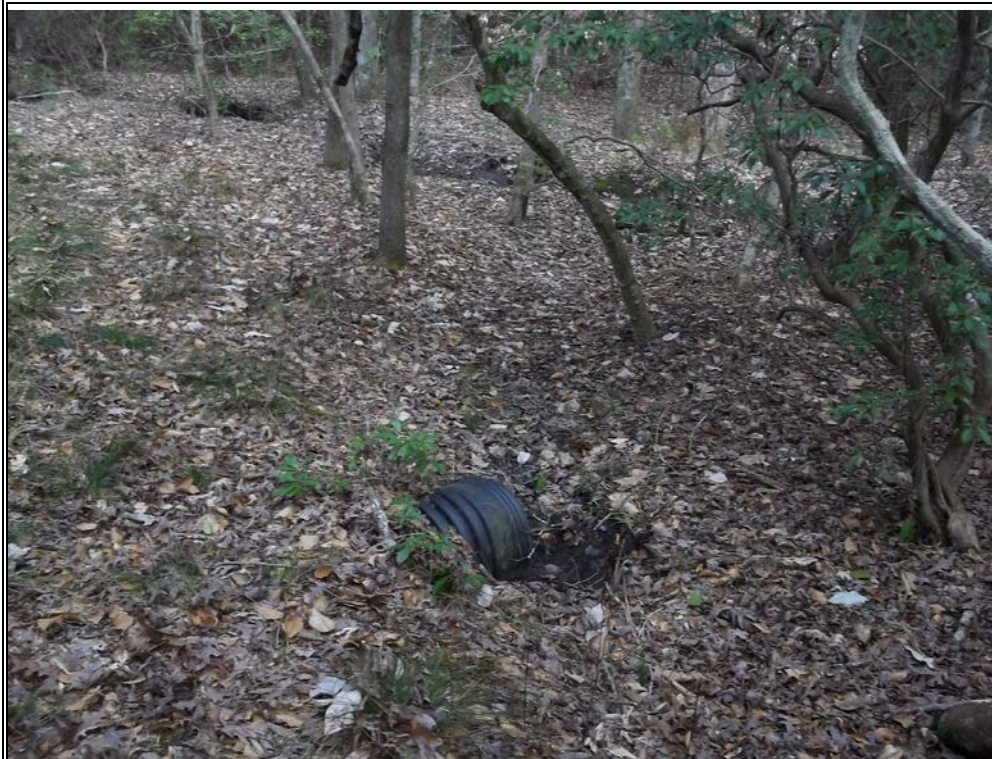
Photo Number
12

Drainage systems include common area landscaped areas and grassed swales around the pool area. Stormwater piping is also located under sections of the walking trails in the community. Periodic repairs will likely include retrenching of swales to improve flow, adding rip rap or vegetation to stabilize exposed or steep areas, repairing drainage piping and drainage systems around the trail and other drainage improvements. Reportedly, the association will fund drainage improvements from an annual landscape budget.

Description:
Small drainage
pipe under section
of walking trail.

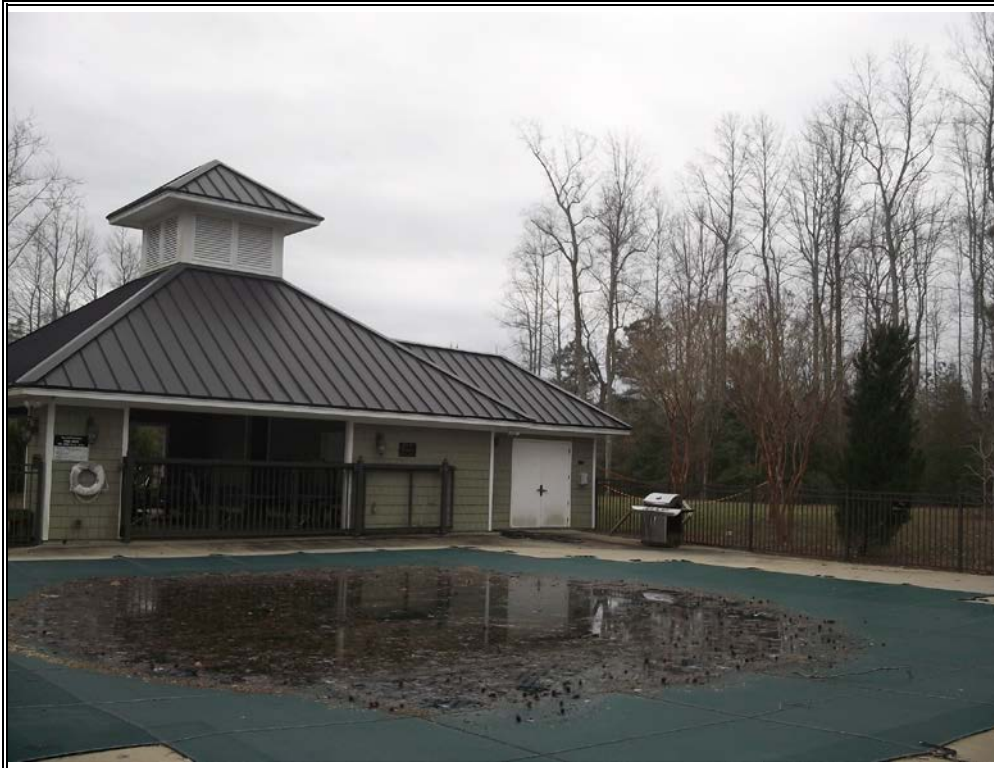
Photo Number
13

The pool cover was observed to be in fair to poor condition with torn areas observed. We have allocated funds to replace the pool cover on a 10 year cycle beginning in 2017.

Description:
Pool building, pool
cover.

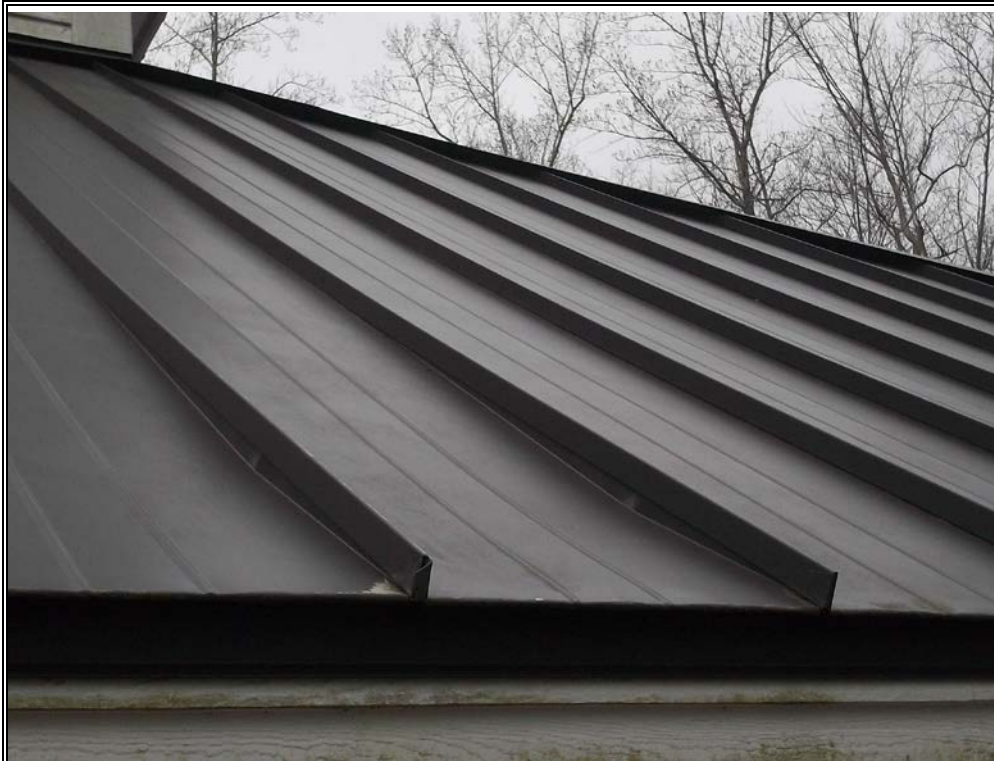
Photo Number
14

The predominant pitched roof surfaces over the pool house is covered in standing seam metal roofing. Roof surfacing is applied over plywood roof sheathing, and appears to be in good condition. Minor improvements over the term will likely include replacing vent boots, flashing and drip edge repairs which we have assumed would be funded from an annual maintenance budget.

Description:
Standing seam
metal roofing on
pool building.

The standing seam metal roofing will not likely require replacement until well beyond the term of this study. However, the enamel coating will

likely fade in color and begin to deteriorate. We have allocated funds to repair and re-coat the metal roofing on a 20 year cycle beginning in 2025.

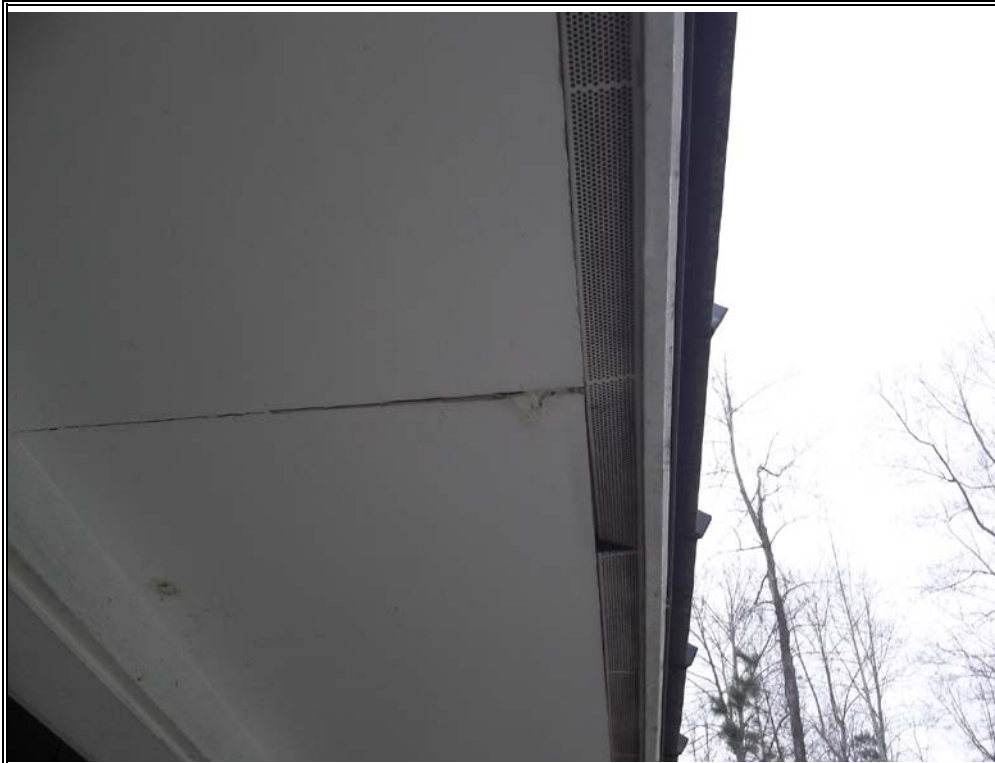
Photo Number
15

The pool house building is of wood framed construction and primarily clad in fiber cement siding and trim. Painted wood ceiling panels are located in the open air ceilings. The painted surfaces generally appeared to be in fair to poor condition with areas of flaking paint, failing caulking and mildew accumulation noted. We have allocated funds for to repair and paint the pool building exterior cladding in 2017 and continuing on a 7 year cycle thereafter.

Description:
Deterioration
noted in exterior
surfaces of pool
building.

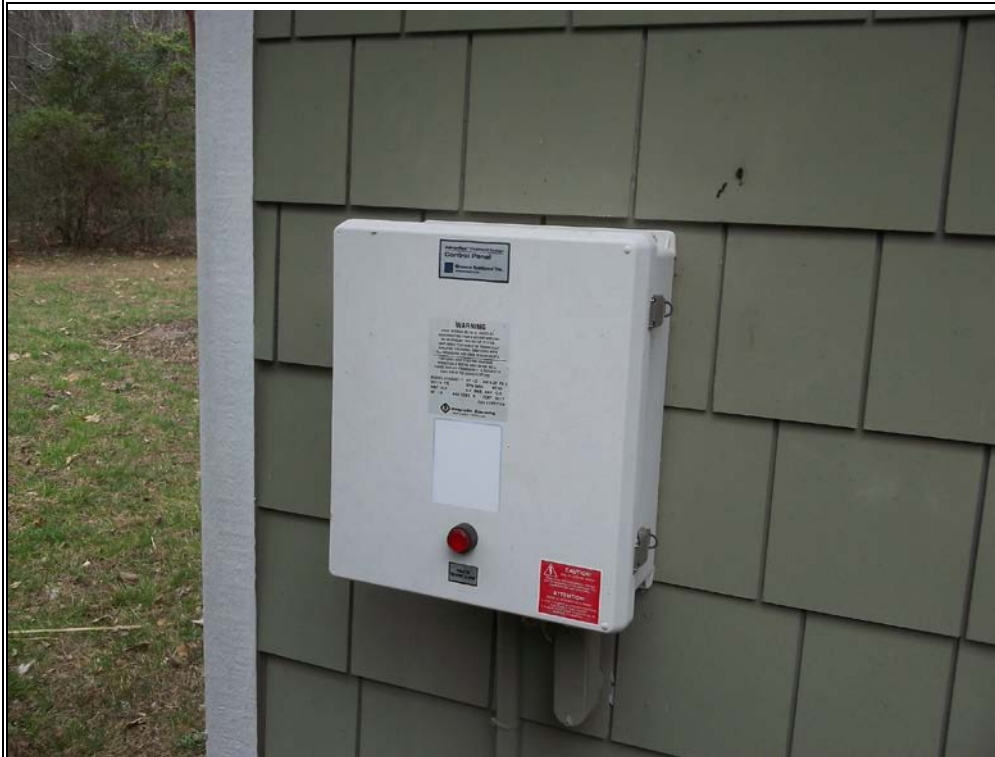
Photo Number
16

The pool building is served by a well and an engineered septic system with tanks and a pump. The well includes a Well Mate pressure tank and a Crystal Right CR200 water softener/filter. The septic system includes an Advantex Treatment System Control Panel with a 1 horsepower recirculation pump and a 3 horsepower discharge pump. The system components have varying expected useful lives and are typically repaired/replaced as they fail. We have allocated funds to repair the well and septic system on a 15 year cycle beginning in 2025.

Description:
Septic system
control panel.

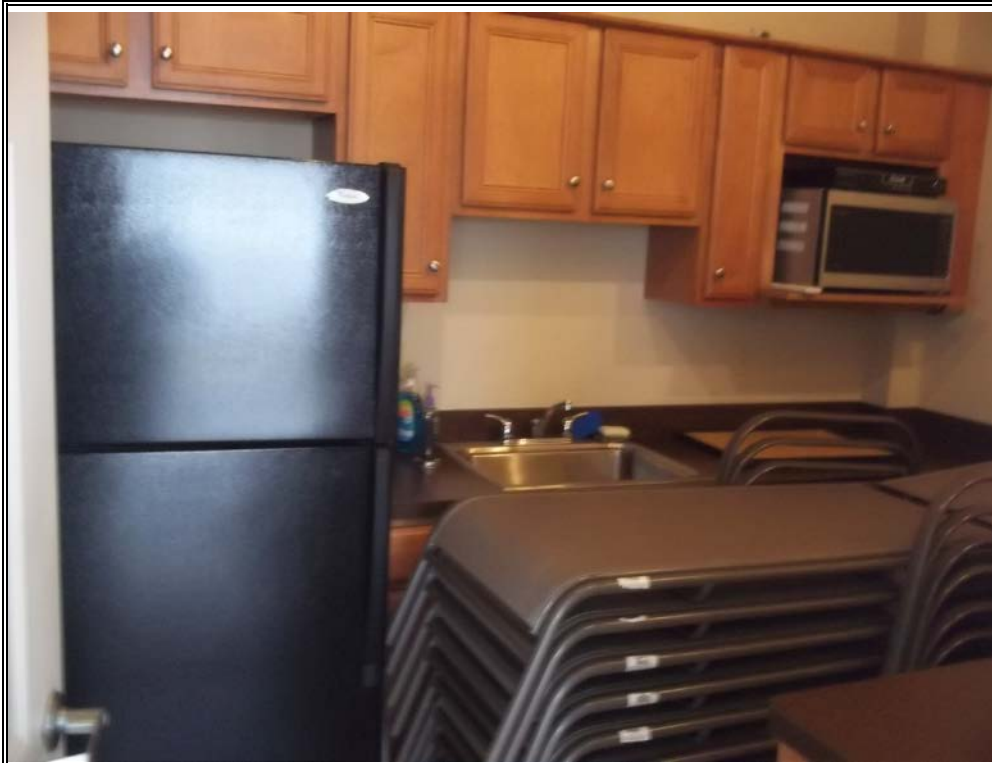
Photo Number
17

Description:
Kitchen area, pool
furniture storage.

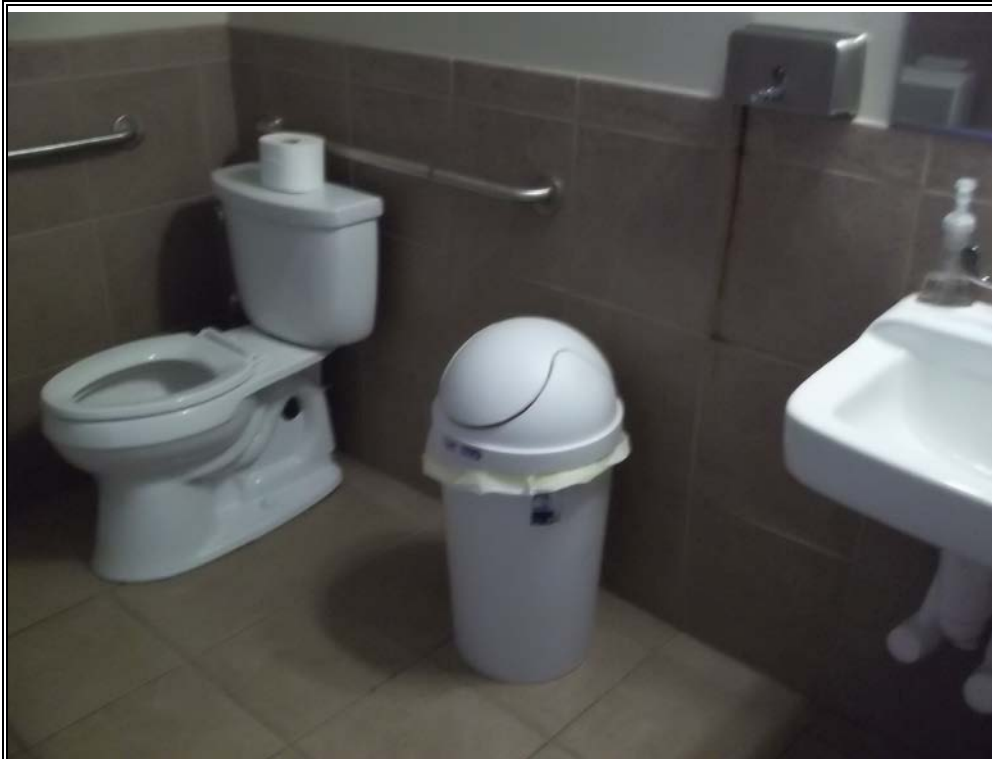
Photo Number
18

The pool house building includes men's and women's restrooms. Each restroom includes a toilet and wall mounted sink with ceramic tile flooring and wall tiles. The small kitchen area includes cabinets, countertops a sink and basic appliances. The restroom and kitchen fixtures, cabinets and appliances generally appeared to be in good condition. Reportedly the association plans on completing any necessary repairs to the kitchen and bathroom fixtures from an annual maintenance budget.

Description:
Restroom fixtures.

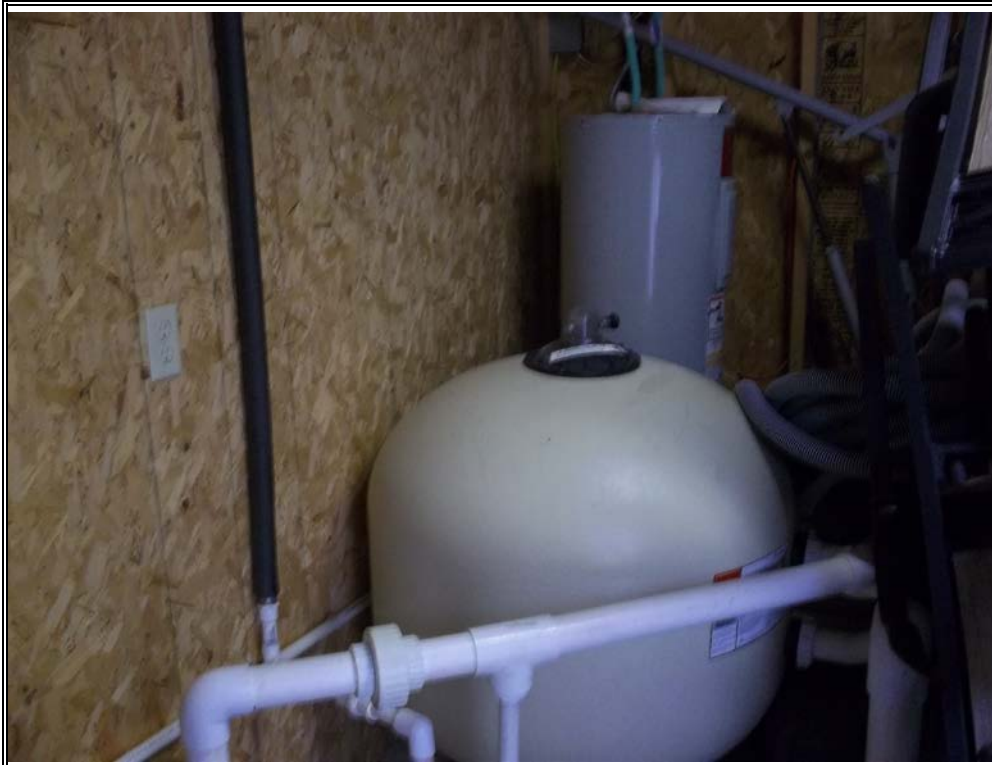
Photo Number
19

The pool building includes a 40 gallon electric water heater which has an expected useful life of approximately 15 years. Reportedly, the water heater has not been used in several years and the association will fund any necessary repairs from other sources.

The pool pump and filtration equipment includes a 2.5 horsepower pump and sand filter with a recently replaced auto-chlorinator systems. These components are typically replaced as they fail and we have provided an allocation of funds to repair the pump and filtration equipment on a 3 year cycle beginning in 2019.

Description:
Water heater, pool
filter.

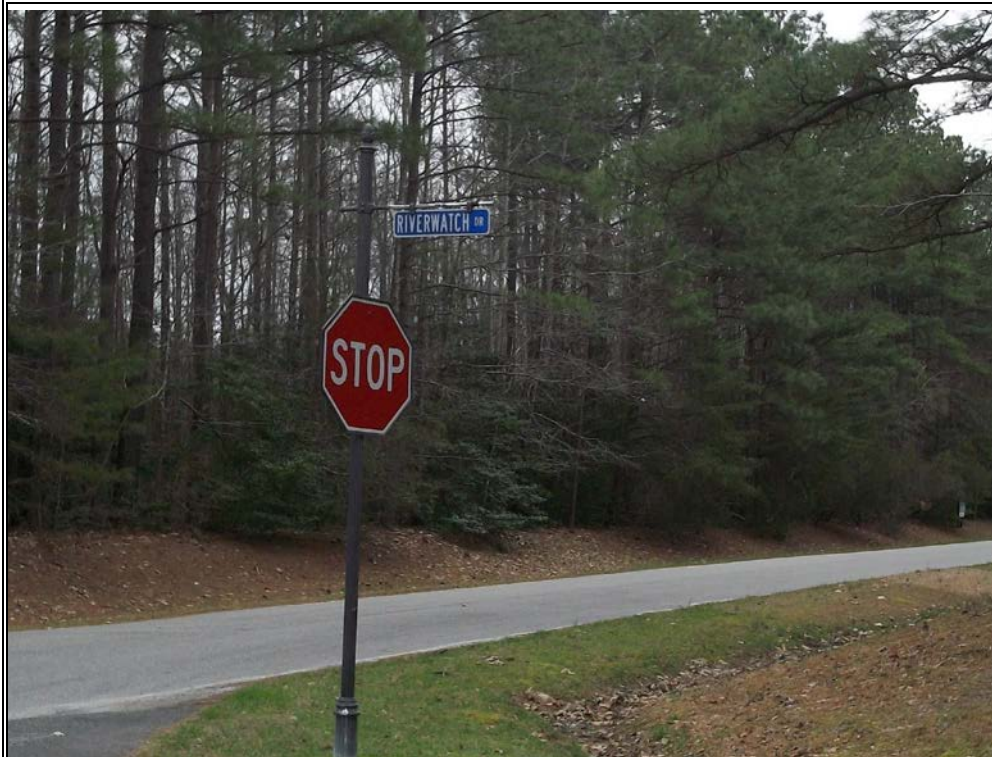
Photo Number
20

Custom street signs are located throughout the community. Typically, the county/DOT will only maintain and replace standard DOT spec street signs. We have assumed the association will be responsible for maintaining and replacing the street signs and have allocated funds for their replacement based on cost information provided on a 25 year cycle beginning in 2027.

Description:
Custom street sign
in community.
